REPORT NO. CG-D-02-79

IDENTIFICATION AND EVALUATION OF
DEEPWATER PORT HOSE INSPECTION METHODS

U.S. DEPARTMENT OF TRANSPORTATION
RESEARCH AND SPECIAL PROGRAMS ADMINISTRATION
Transportation Systems Center
Cambridge MA 02142

FINAL REPORT

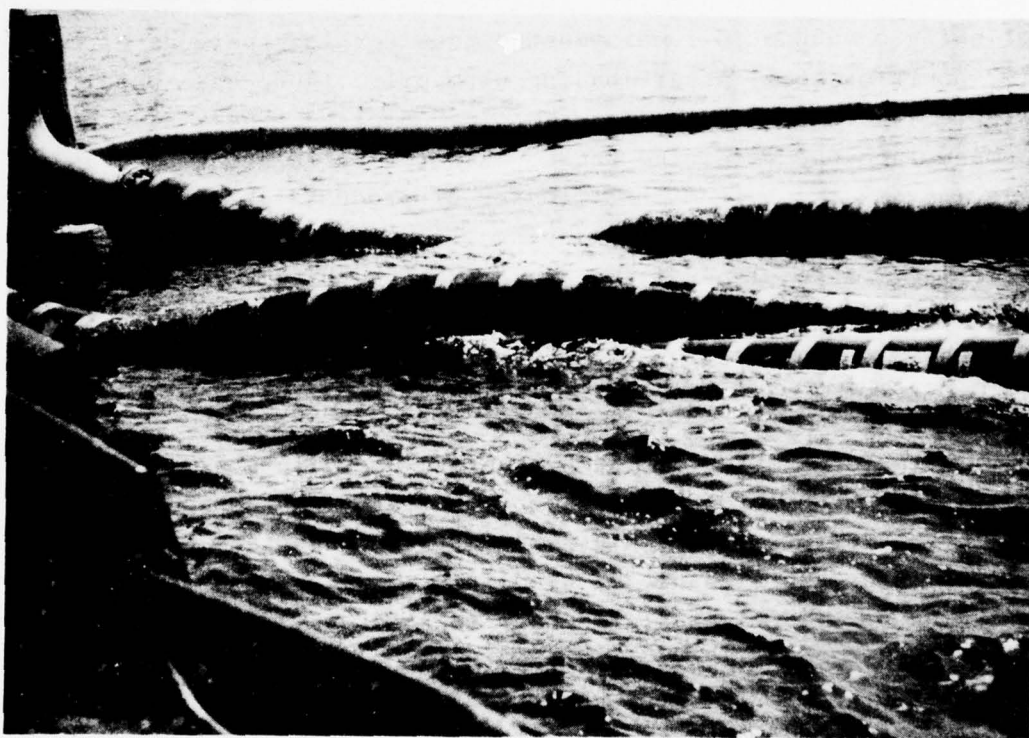
FIGURE 5-4. HOSE OVERLAPPING

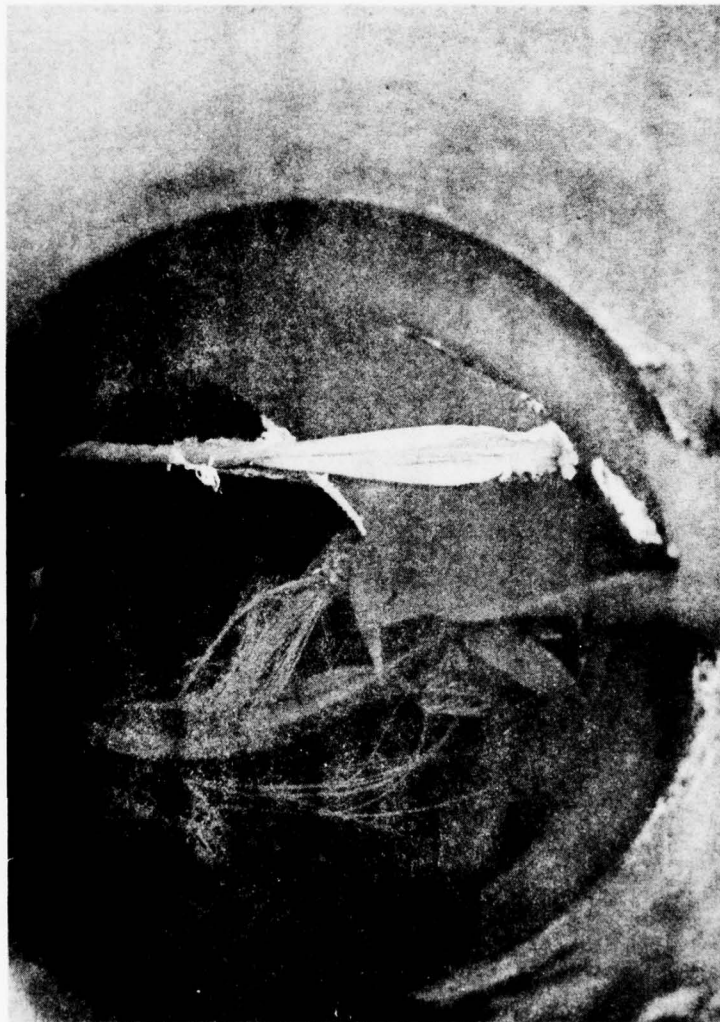
FIGURE 5-6. LINER FAILURE

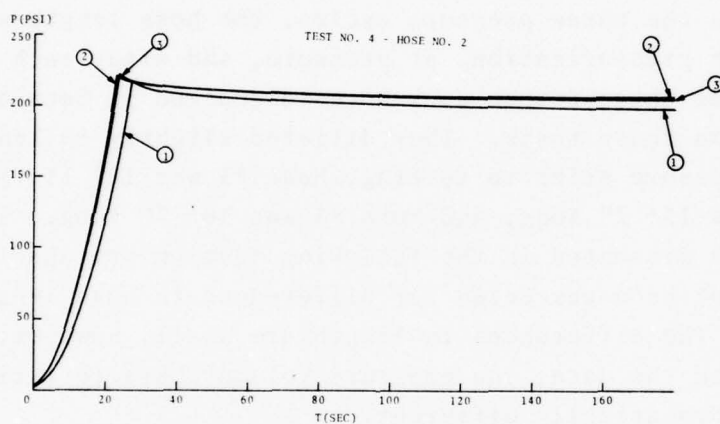
Figure 7-4b (hose #2) is data from the hose whose liner failed and had a small leak of a few drops per minute. The curves exhibit a much shorter pressurization time than the new hose. It was suspected that significant structural design differences existed between the hoses. This was confirmed by examination of the hose

FIGURE 7-4b. DOCK HOSE PRESSURE-VOLUME DATA (HOSE NO. 2)

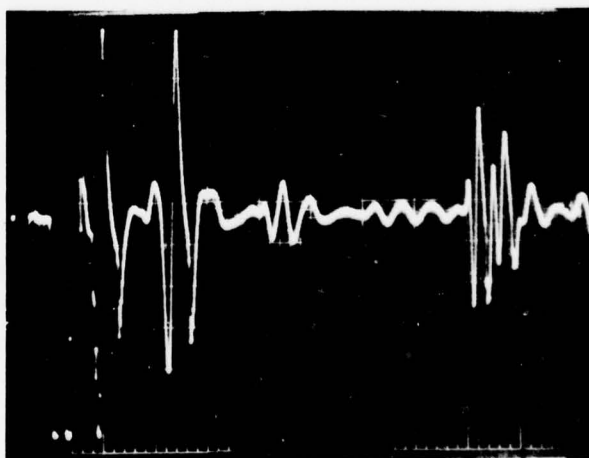
FIGURE 7-8. ULTRASONIC SCAN OF HOSE WITH LINER SEPARATION
